# ZILWAUKEE BRIDGE

Bearing replacement need determined after 18 years of service

by Corey E. Rogers, Michigan Department of Transportation

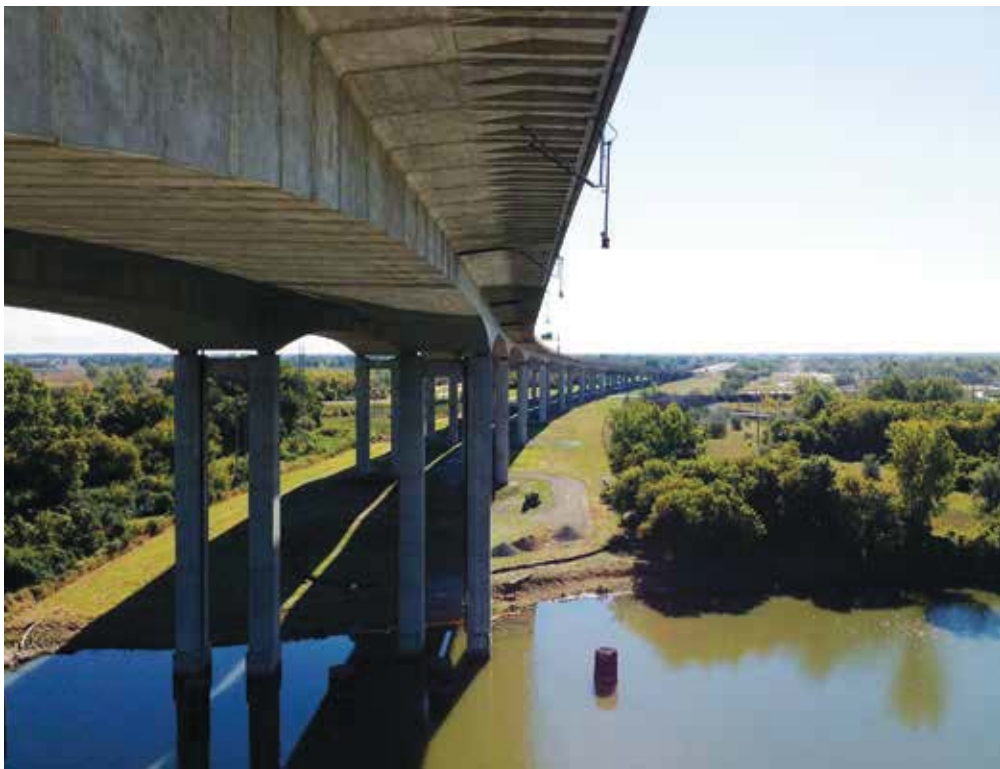
The Zilwaukee Bridge, a 1.5-mile-long twin concrete segmental structure, carries I-75 traffic over the Saginaw River. All Photos: Michigan Department of Transportation.

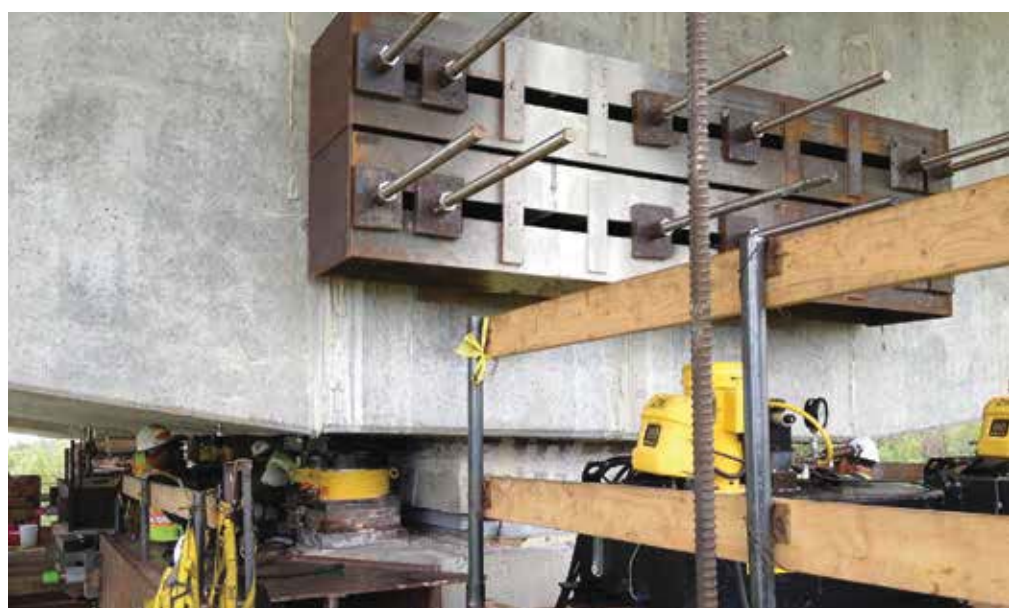
Erection of pier column work platform.

Platforms weighing approximately 90 tons were designed and constructed by the contractor and hoisted into place at the top of the piers with hydraulic jacks and high tensile rods. Twelve 1¾-in.-diameter post-tensioning rods were installed transversely through the box at most of the pier diaphragm locations and stressed to 210 kips each to support the 12 ft by 25 in. load redistribution walers. The smaller diaphragm locations received modifications by placing reinforced, post-tensioned concrete blocks adjacent to the diaphragm and over the jacking points. The larger diaphragms received no strengthening modifications.

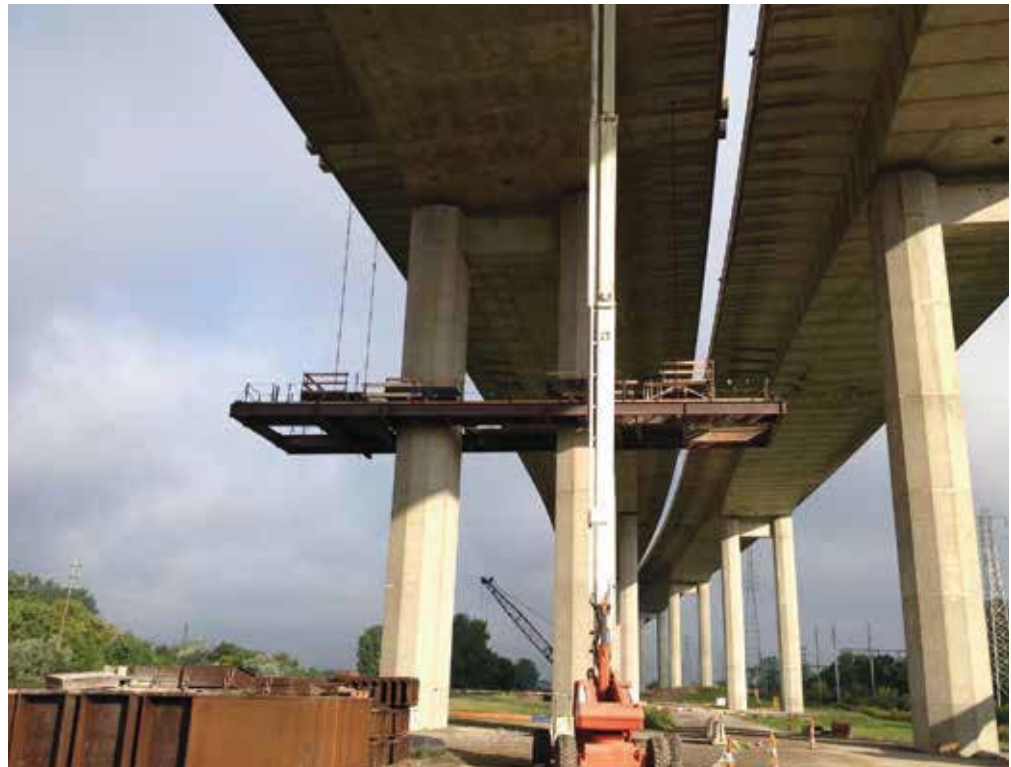
Post-tensioned waler configuration, compression collars, and jack layout at pier bearing.

Two 2½-in.-diameter post-tensioning rods held the compression collars and were stressed to 540 kips each. Up to eight 600-ton hydraulic jacks per bearing were used to lift the superstructure from the bearings. Steel rods were anchored into the pier and bottom of the superstructure,

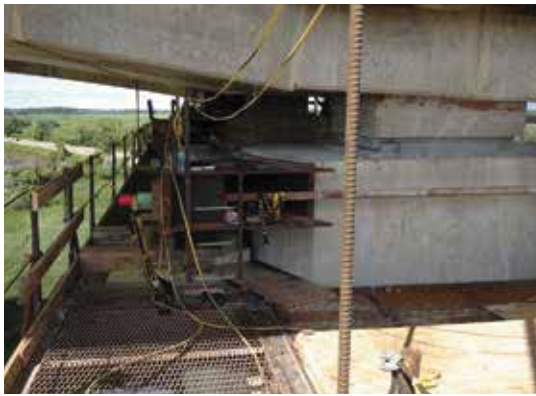
Pier column compression collars.

Early designs called for shoring towers that would support the jacked superstructure from the footings. The contractor proposed placing the jacks on top of the pier columns and horizontally compressing the tops of the columns with pier collars to confine them and prevent column edge spalling at jack bearing locations. This method was determined to be feasible and eliminated the need for costly shoring towers.

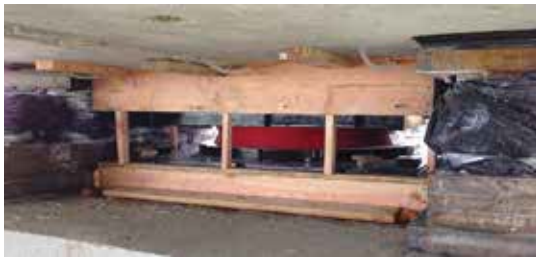
Newly installed pier disk bearing with pressure grouting formwork.

It was also during the construction management phase that MDOT decided to use disk bearings instead of pot bearings. The disk bearing is simpler in design and thinner than a pot bearing, but requires a larger footprint. A polyurethane disk provides the required rotational capacity and a stainless steel top plate coated in PTFE provides the lateral movements. The disk bearings were able to fit into the 4-in.-deep opening at the expansion joints and provide the needed bearing capacity at pier bearing locations. Upon completion of the design phase, a guaranteed maximum price was negotiated, with the final cost of the project totaling

and surveys were used to monitor displacement. The existing bearings and concrete plinth were then removed with the use of a wire saw, the new steel reinforcement was anchored with epoxy into the top of the pier and bottom of the superstructure, and the new disk bearings were set into place. Pressure grouting of bearing pedestals with a non-shrink cementitious grout was conducted and allowed to reach a compressive strength of 5 ksi prior to lowering the structure.
